2000-2006 BMW 3-Series (E-46) Convertible Top Hydraulic Hose #23 or #24 Repair Info Using Cabriolet Hydraulics E46-HR

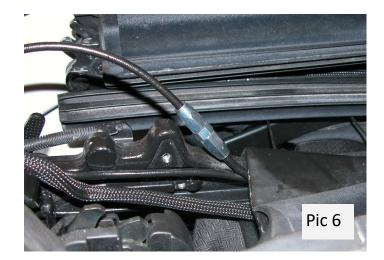
Pic 6 shows the new hose section reattached with the coupler.

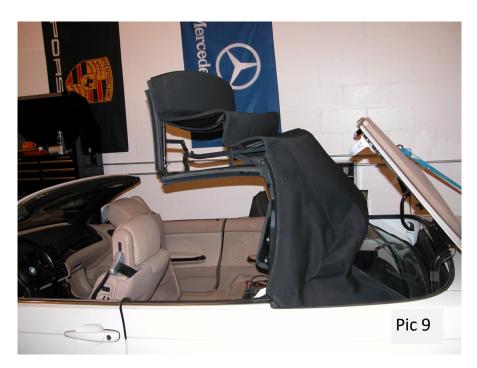
Step 7: Move the top so that the main bow is in a vertical position as shown in Pic 9.

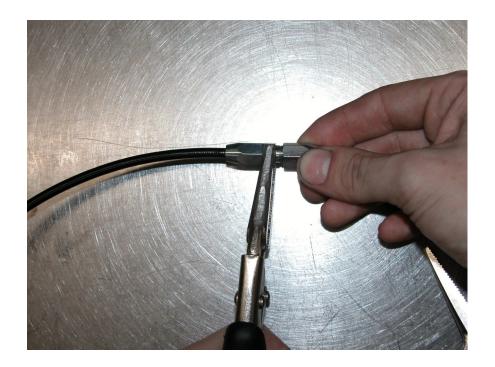
Step 5: To prevent cross threading, thread the crimping nut onto the coupler by hand until resistance is felt. The nut should be 1/8" away from the center hex of the coupler

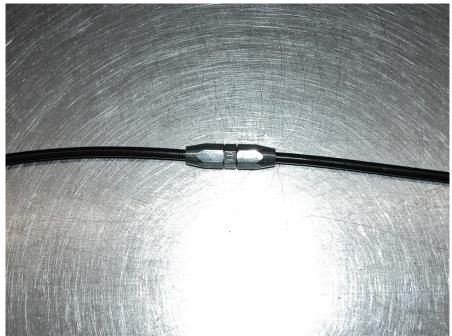
<u>Step 6</u>: Support the center hex with a 10mm open-ended wrench and with another 10mm open-ended wrench or adjustable wrench, turn the crimping nut until it bottoms against the center hex. Rotation will become more difficult as the nut begins to bottom. A defi-nite stop will be felt when the crimping nut bottoms. **Do not over tighten**. The hose re-pair is completed.
